**ONR Report ACR-186**

# Project LRAPP Test Bed

Technology Used in the Development of a Deep-Ocean Stable Platform

October 24, 1972

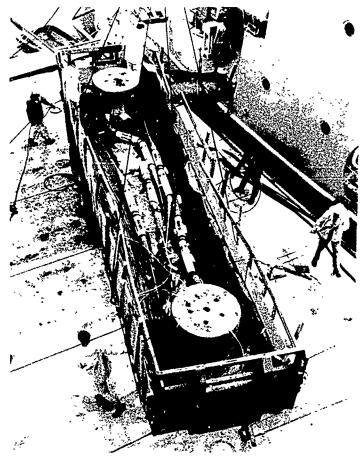
(U) Fig. 25c—Removal of twists in the array cable during loading into the Naubuc. The truck bed, supported by the crane, is being rotated.

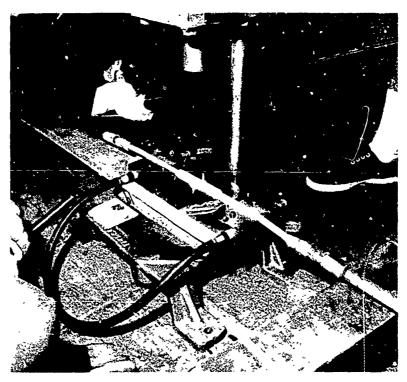
(U) Fig. 26c—In-line splice, necessitated by the third kink, is removed from the mold

- (U) At about 8 p.m. on December 3, the second buoy was deployed in the same manner as the first without incident and the payout of the inshore riser leg begun. However, later that evening a third kink developed between the cable tank and the draw-off and hold-back machine which required that the damaged area be cut out and mold spliced (Fig. 26c). The severed armor was then bridged with a 13-foot length of preformed grip, which in addition was strain relieved with a 1/2-inch-diameter wire-rope preventer. This repair task required a half day, and it was not until early afternoon on December 4 that the inshore anchor assembly and the cable driver were deployed. By that time the project had exhausted the fair weather.
